FAILURE ANALYSIS AND PREVENTION OF METALLIC STRUCTURES AND COMPONENTS FROM NPP: CASE STUDY

Manuela FULGER¹, Maria MIHALACHE², Dumitra LUCAN³,
Lucian VELCIU⁴

The goal of the current study was the analysis of one threaded rod from the elastic suspension of the raw water pipelines from Cernavoda NPP to identify the causes that led to its breakage.

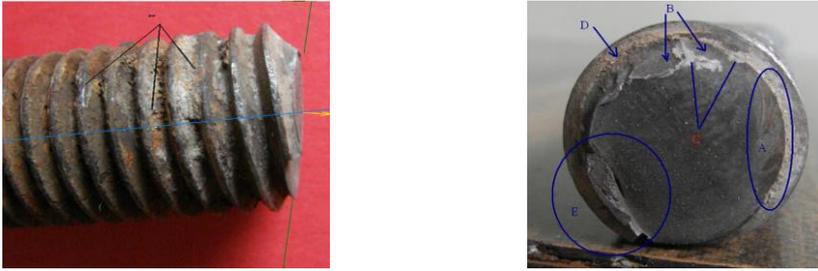
- The rod had one end screwed into the lower board of the sprind guide, while the other end was welded;
- The rod had an imprint due to the friction with the guide plate and was bent near the welded end
- The thread of the rod is corroded, presenting rust (Figure 1a).
- The thread of the rod was corroded, showing traces of red color (rust) which in some places were quite thick.

Figure 1. The threaded rod (a) and the fracture surface (b)

Analysing the fracture surface (figure 1b), the following were observed:

- a crack due to torsion (the zone A), caused by inadequate or excessive screwing.
- surfaces with different orientation to the fracture surface (the zone B).
- light grey colour surfaces (the zone C).
- region with reddish coloration, suggesting the presence of corrosion products that entered into breaking zone (the zone D).
- final breaking region (the zone E), with torn material.

Aside from the above mentioned regions, the fracture surface was smooth, indicating a fragile break, possibly through fatigue mechanism.

Because on the fracture surface reddish zones (rust) were observed, it was concluded that they were formed before the break. Moreover, it was observed a crack produced by torsion (in the zone A), due to an inappropriate or excessive threading, as well as a crack at the bottom of the thread (zone D).

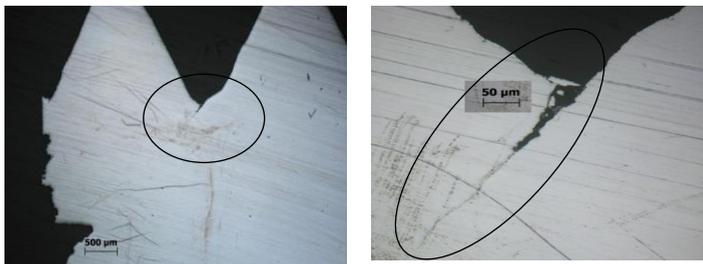
The metallographic analysis followed the fracture surface analysis. Thus, from the threaded part of the rod a sample was cut which was longitudinally sectioned. Through optical microscopy have been revealed a crack at the bottom of the thread (Figure 2). A larger detail shows that the crack is very long and sharp at the tip, which means a high concentration of tensions at tip.

Figure 2. a) Crack inside of the thread (x100) b) detail (x200)

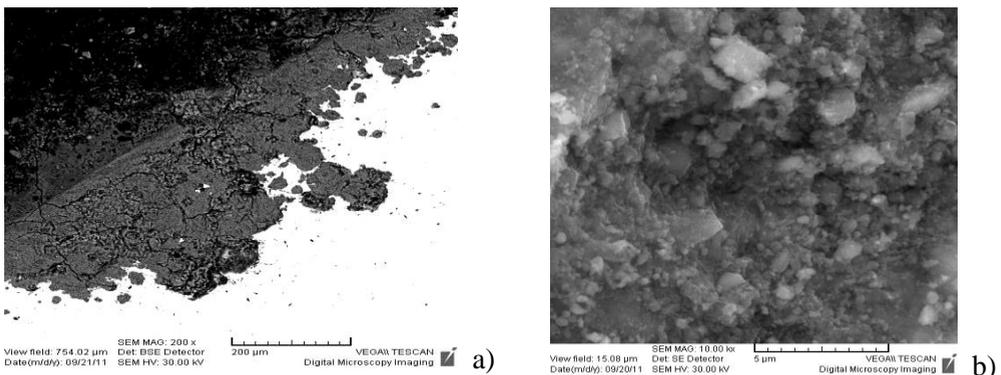
Furthermore, the corrosion products found at the bottom of the thread (the zone D) were analyzed and the thickness of the products indicated a long time for developing. At higher magnification (Figure 3b) the crystalline structure of the oxides can be observed (generally magnetite and hematite, based on their shape).

Figure 3. Corrosion products inside of the thread; a) BSE image b) detail (x10000 magnification)

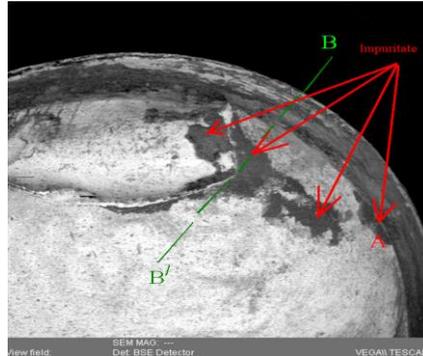
The zone C from figure 1 (light grey colored), was marked as the crack initiation. Generally, in fractography, different colored regions indicate a difference in atomic number, more precisely the presence of impurities. In the Figure 4, the zones considered to be impurities are highlighted with red arrows. In order to identify the chemical elements, the impurities were analyzed through the EDS technique.

Figure 4. BSE image of the fracture surface

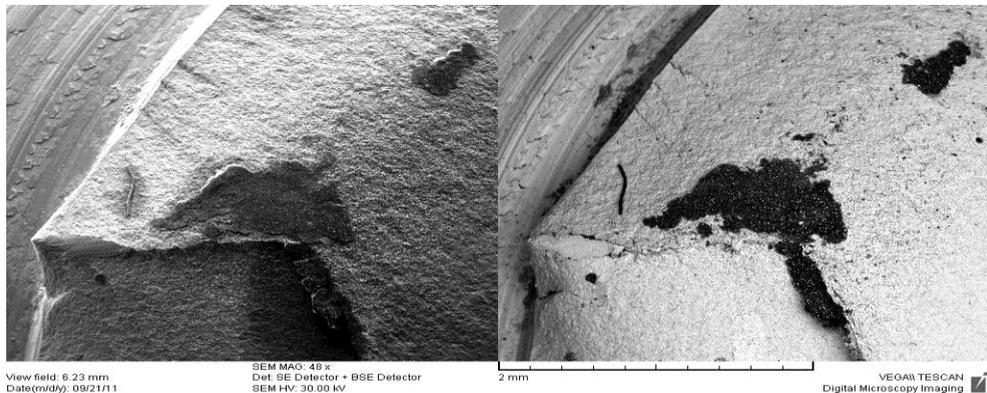
In Figure 5, it can be observed that in the impurities region (indicated above by red arrows) the fracture surface changes the orientation plane, which led to the conclusion that in this region the fatigue fracture nucleated.

Figure 5. SE image of the surfaces with different orientation than fracture plane (region B)

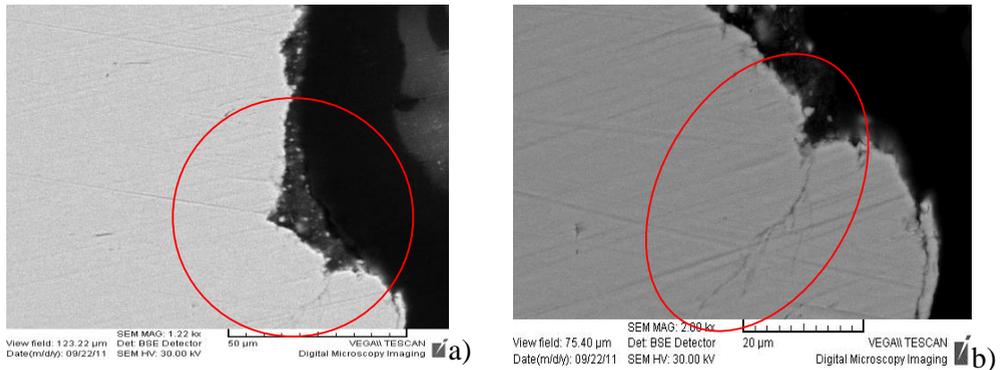
For a more detailed analysis of the impurity from which the fatigue nucleated, a cut was made through the impurity, the examined section being presented in the Figure 6. Around the impurity it was observed the cracked material which means that the fatigue crack propagated progressively after nucleation.

Figure 6. a) BSE image of the section through impurity b) detail

The development of the crack was explained by the concentration of tensions at the bottom of the thread during screwing process. Also, the cracks could be caused by a chemical composition not conforming to the standards (XRF analysis) or by a hardening of the material (Brinell hardness test demonstrated that comparatively with the standard hardness (180 HB), the measured hardness was greater (195 HB).

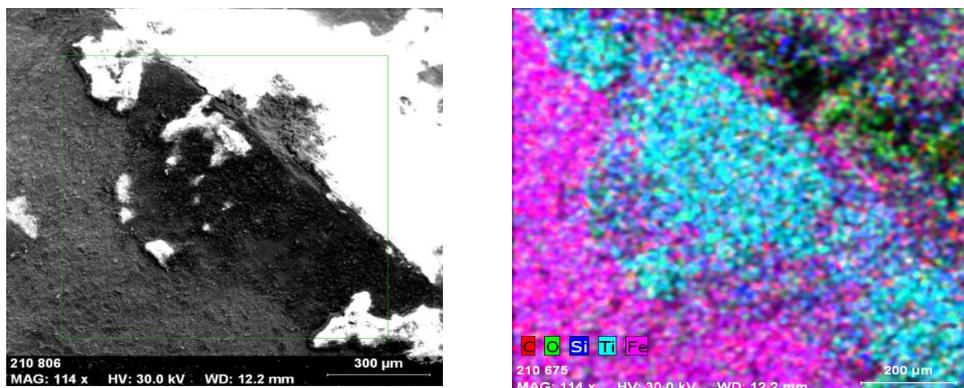
EDS analysis identified the presence of impurities in the fracture surface. The Figure 7 presents the images obtained with secondary electrons and the elemental map.

Figure 7. SE image with elemental compounds (C, O, Si, Ti) of the impurity

After elemental cartography, titanium was identified in the impurity (normally, titanium is not a part of a carbon steel), combined with carbon and with

silicon particles. The concentration of titanium and carbon has been observed only in the region of the impurity, comparatively with the rest of the alloy, which is preponderantly iron . Thus, we concluded that the impurity appeared during the fabrication process, titanium carbide and sand being included in the material during manufacturing.

Prior to mounting the threaded rod, it is recommended that the material used is verified to be conform to the technical specifications (composition, hardness, etc.) and with the project specifications.
