# CORROSION DEGRADATION STUDY OF SHELL AND TUBE HEAT EXCHANGERS IN PETROCHEMICAL PLANTS

**Abstract:** *This paper presents the research results carried out to evaluate the degradation and lifespan of a heat exchanger used for heating salt water (containing hydrocarbon traces) within a petrochemical plant. Initial static tests, including corrosion tests, were performed, followed by an investigation into the most common failures and their mechanisms affecting the heat exchanger's shell and tubes. Corrosion testing indicated susceptibility to pitting corrosion, particularly at elevated temperatures. Finally, methods for monitoring heat exchanger performance were proposed.*

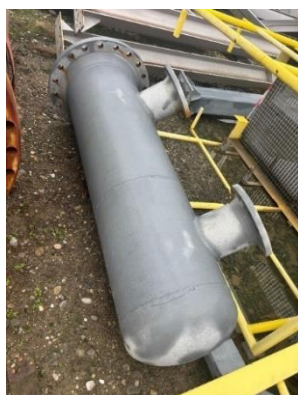
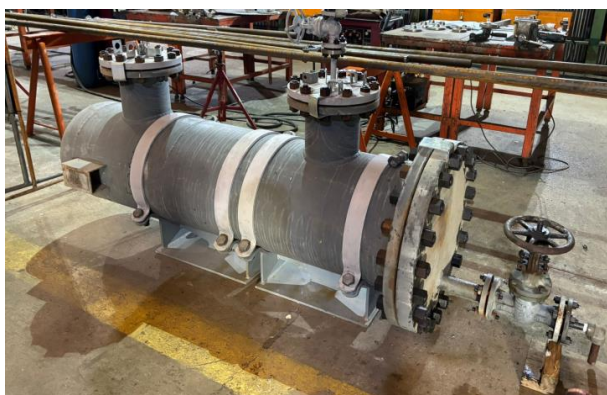
**Fig.1.** Shell-and-tube heat exchanger.

Exchanger under  
maintenance / repair

Heat exchanger after repair / maintenance

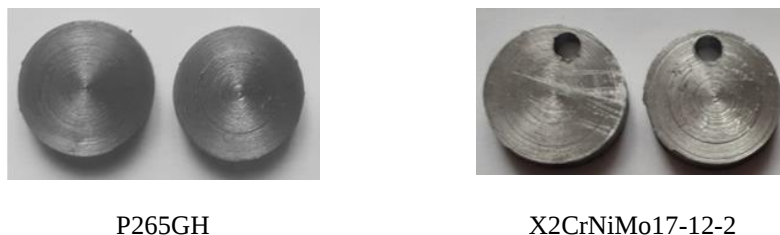
The test specimens are plate-type (Figure 2). Two categories of materials were used for the fabrication of the specimens: P265GH EN 10216-2:2024 and X2CrNiMo17-12-2 EN 10216-5:2024. A total of 4 specimens were machined and codified according to Table 2.

**Fig. 2.** Test specimens used for the corrosion evaluation.

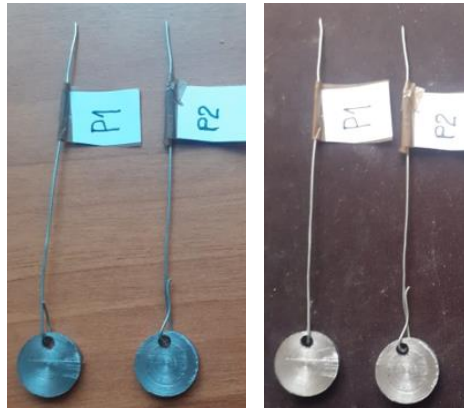
**Fig. 4.** Corrosion specimens prepared for insertion into the working fluid.

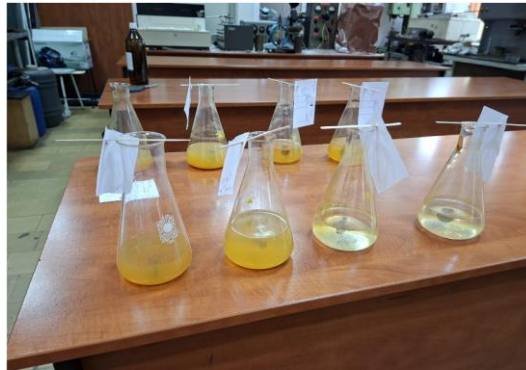
**Fig. 5.** Immersion of specimens into the test vessels.

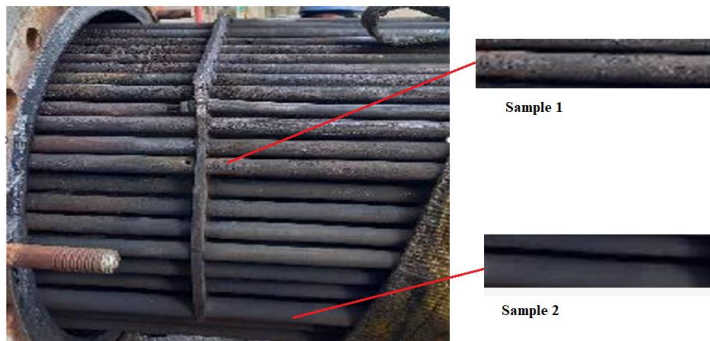
The tubes represent the most exposed component of a heat exchanger, featuring reduced wall thicknesses (5...7 mm) to facilitate heat transfer, which makes them extremely sensitive to degradation. Tube coupons were extracted from various critical zones of the heat exchanger (Figure 8).

**Fig. 8.** Tube sampling.

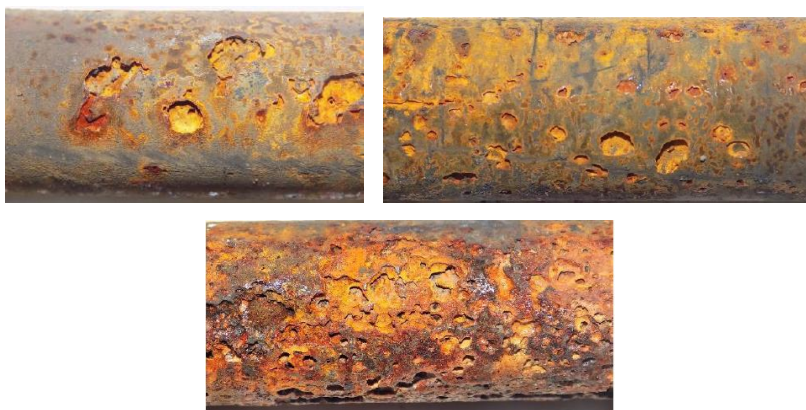
Macroscopic examination of the samples taken from the heat exchanger tube bundle, sample 1, indicates severe localised pitting corrosion on the outer surface of the tubes (Figure 9).

**Fig. 9.** Aspects of pitting corrosion and under-deposit corrosion (crevice and pitting cavities) – sample 1.

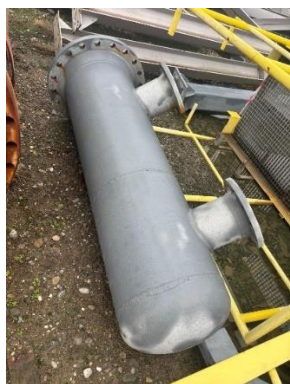
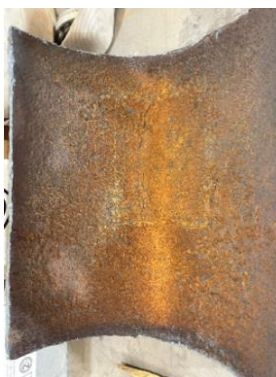
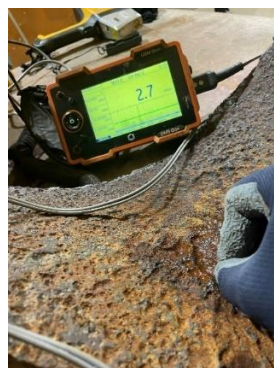
- *Localized corrosion pitting.* High density of active micro-cavities, with hemispherical geometry, oriented perpendicular to the metal wall. These represent electrochemical initiation points where the passive oxide layer has been locally penetrated by active chlorine and sulphur ions from the dissociation of salts present in the F1 medium.

- *Macroscopic corrosion craters and caverns.* By the union of adjacent pits and under the action of fluid hydrodynamics, extensive corrosion cavities have developed under the layer. Profilometric and ultrasonic measurements performed in these indicated areas record critical penetration depths, ranging between 2.0 mm and 3.0 mm.

**Fig. 14.** Shell – visual appearance:  
*a* – decommissioned shell; *b*, *c* – sample cut from the shell.
